Yaesu FT 1000 PA Board Failure

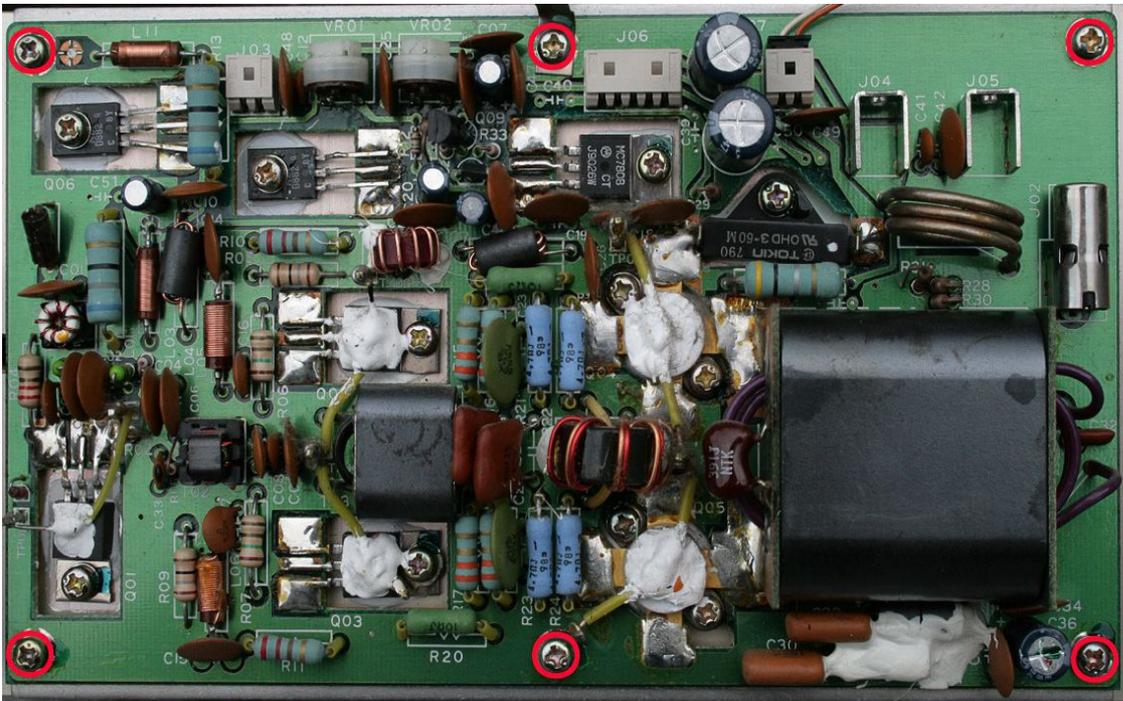
Image 1

Eventually with all new components installed and new thermal compound under the transistors, we were ready to switch on. The finals idle current was adjusted without trouble but the driver current was extremely high and would not adjust at all. After rechecking everything again and soldering on an odd pair of diodes in place of D7003 & D7004 everything worked. I mounted the replacement diodes in place of the originals and switched on again. (Image 1 & 2)

Mounting these correctly resulted in the original overcurrent symptom recurring. It turned out that the solder lug which holds down Q7006 was intermittent! Although it was firmly tightened down, gentle flexing caused the earth bond to come and go.

I soldered a short length of wire from this lug to the PC board earth plane and did the same to the diodes in the final stage as well. Switch on, press the MOX button and NO SMOKE! The idle current was adjusted to give 260 millivolts across R7014 (100 Ma) and now the rig worked just the way it should. (Image 3).
